Final
Five-Year ROD Review Report
First Five-Year Review Report for
Allegany Ballistic Laboratory
Superfund Site
Rocket Center, West Virginia

June 2002

**Allegany Ballistics Laboratory Superfund Site
Rocket Center, West Virginia**

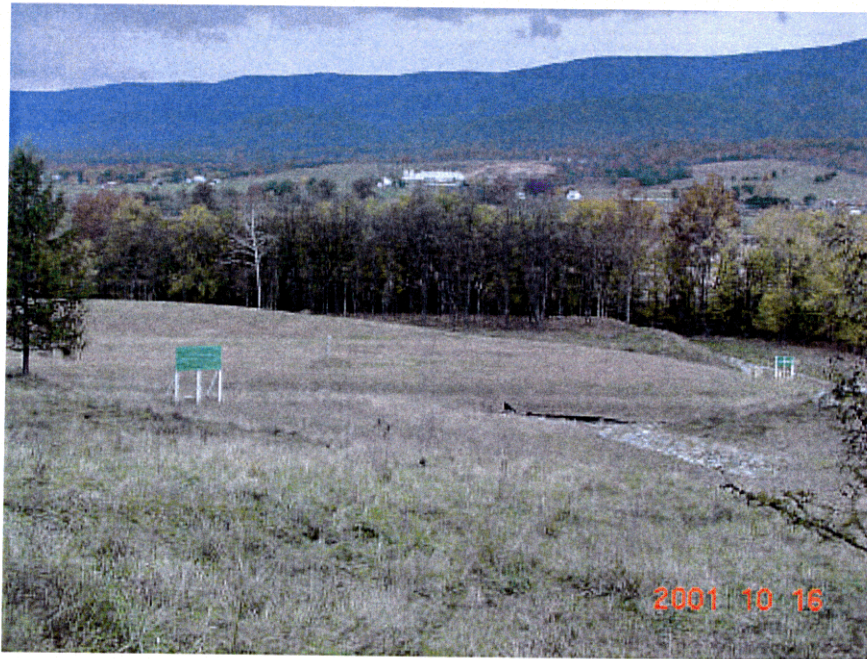
Photograph No.: 1

Description: Site 5 Landfill Cap showing the locations of two of the landfill perimeter access restriction signs. Note the segment of the perimeter rip-rap surface-water drainage channel in the foreground.

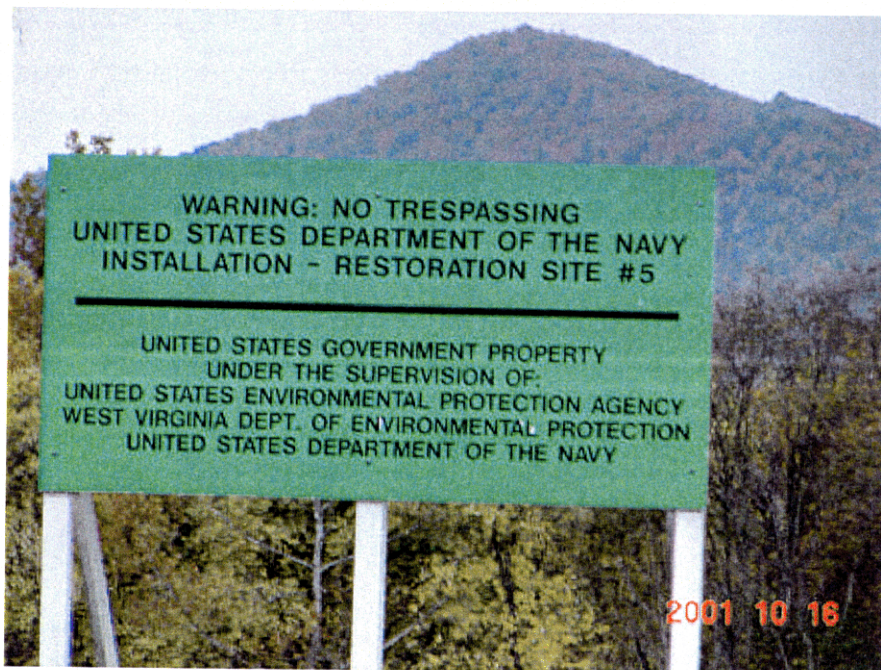
Photograph No.: 2

Description: Close-up of a Site 5 landfill access restriction sign.

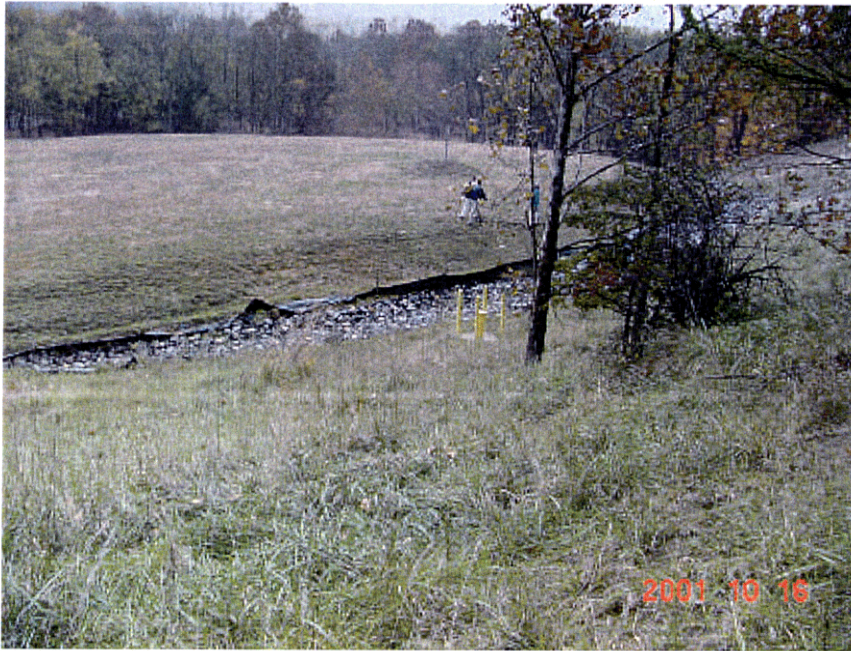
Photograph No.: 3

Description: Site 5 landfill cap from adjacent embankment. Note the perimeter drainage channel and landfill gas monitoring well 5LGMW01 in the foreground.

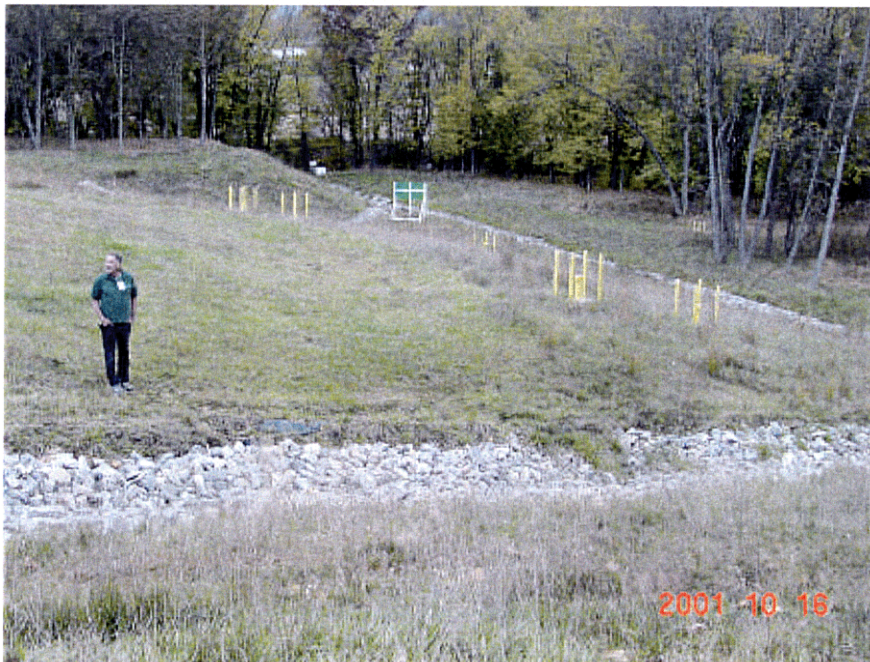
Photograph No.: 4

Description: Western edge of Site 5 landfill cap. Note perimeter drainage channel and several groundwater monitoring wells.

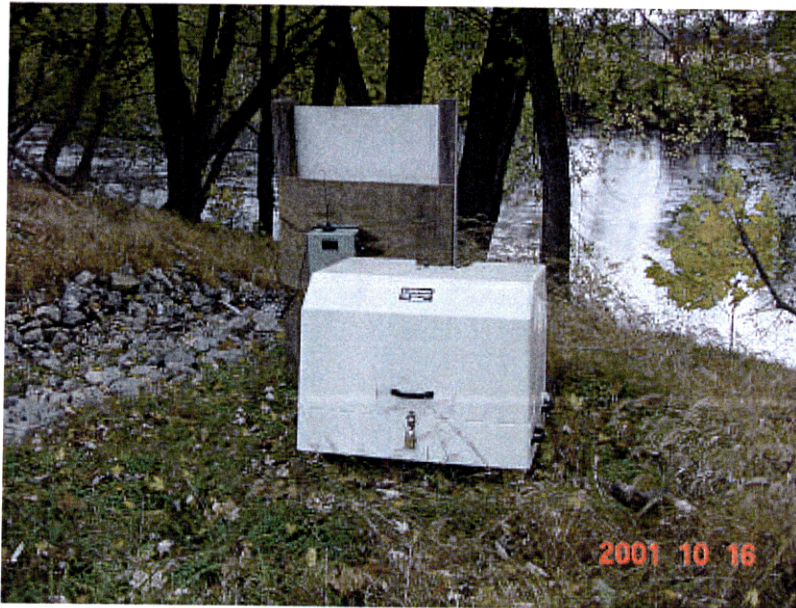
Photograph No.: 5

Description: Close-up of the stormwater runoff autosampler at the perimeter drainage channel outfall to the North Branch Potomac River.

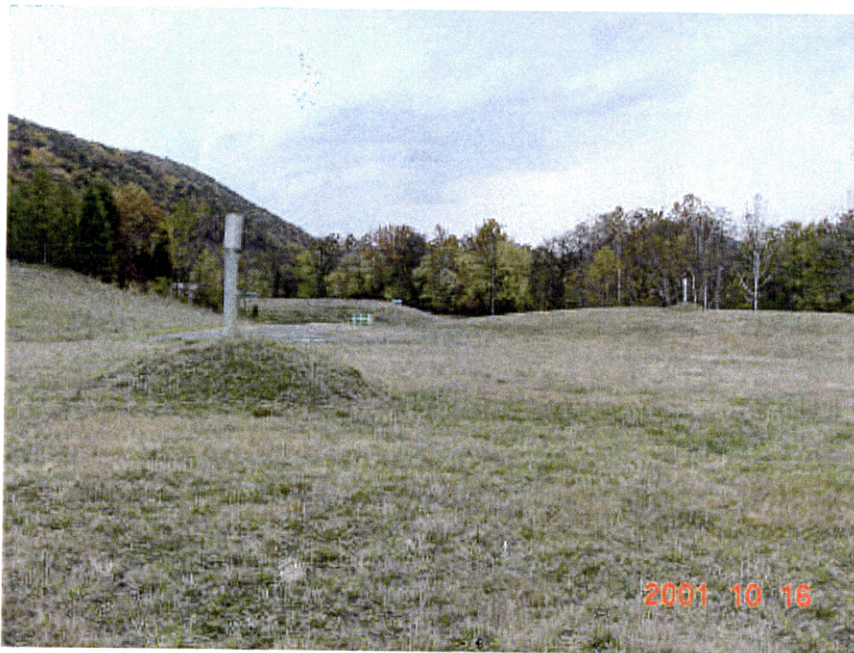
Photograph No.: 6

Description: General condition of the Site 5 landfill cap. Note the landfill gas vents in the background and foreground.

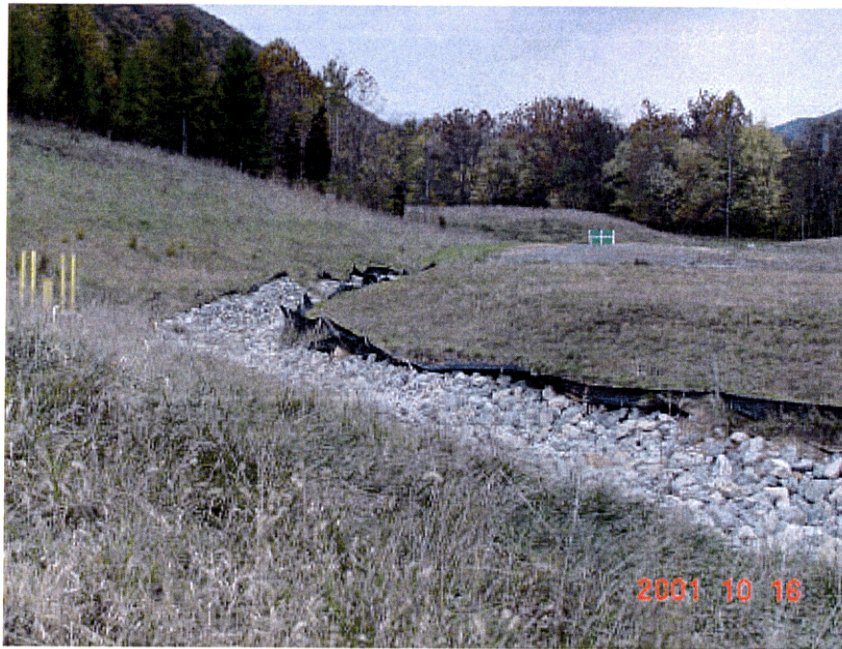
Photograph No.: 7
Date: October 16, 2001

Description: General view showing eastern edge of the Site 5 landfill, a portion of the perimeter drainage channel, landfill gas monitoring well 5LGMW01, and the adjacent embankment.

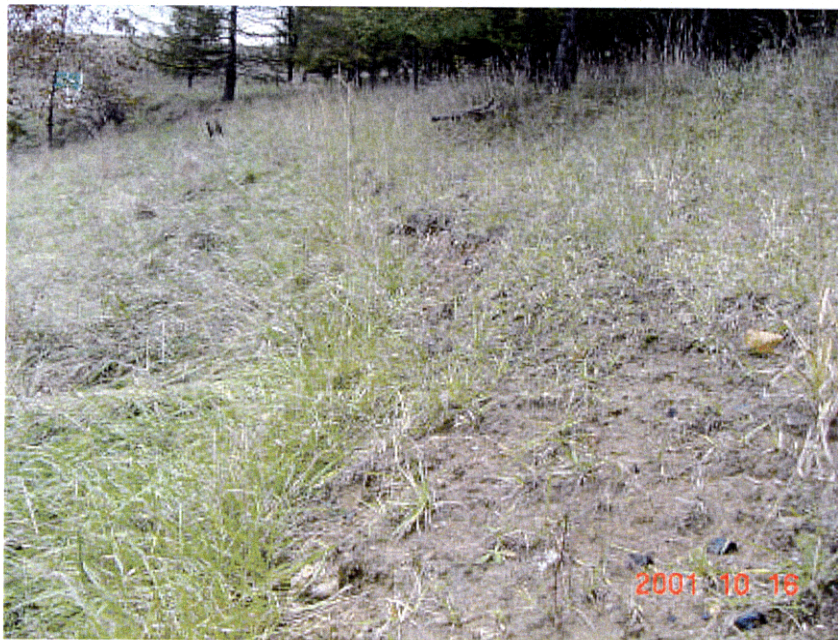
Photograph No.: 8
Date: October 16, 2001

- ***System Operations/O&M:*** Operation and maintenance of the cap and drainage structures has, as a whole, been effective. During site inspections, slope creep has been observed on the hillside above Channel 4; however, this condition currently does not affect the performance or integrity of the cover system, but will continue to be monitored. Minor problems are corrected during the inspections, while more substantial repairs (e.g., access road repair) or modifications (e.g., installation of stormwater autosamplers) are first approved by the Navy.

Description: Close-up of the area of slope creep on embankment adjacent to east side of landfill.

- Prepare and implement a LUCIP for Site 5
- Monitor slope creep of the hillside above Drainage Channel 4 and make any necessary repairs
- Initiate and maintain a permanent compilation of all future repairs and corrective actions performed as part of O&M
- Update the Site 5 O&M and Long-Term Monitoring Plans to reflect current procedures
- Undertake a study to evaluate the extent of the methane gas and to determine whether corrective action is warranted

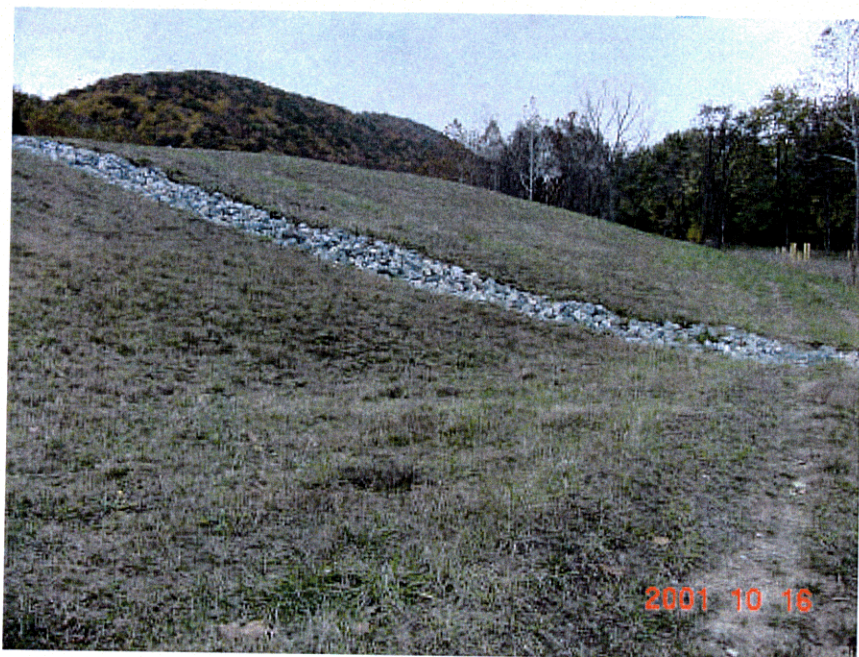
Photograph No.: 9
Date: October 16, 2001

Description: General view showing western edge of the Site 5 landfill.
